An Evaluation of Different Material Line Insulators under High Voltage AC and Bipolar DC Excitation in a Marine Polluted Environment

by
Gerton Nicolaas Jacobus Mouton

*Thesis presented in partial fulfilment of the requirements for the degree
Master of Science in Engineering at Stellenbosch University*

December 2012

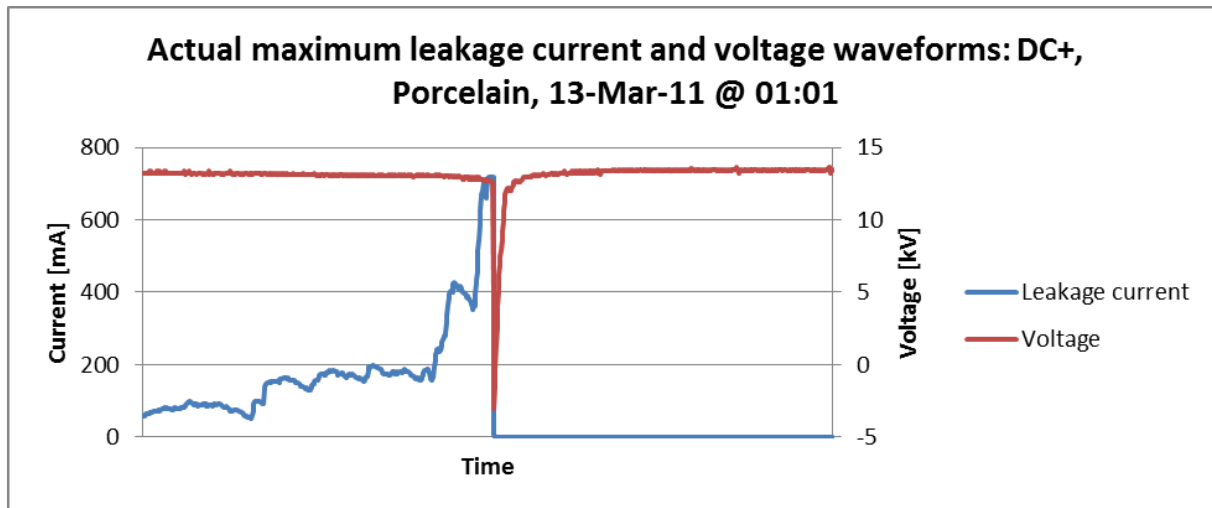
Figure 5-67: Actual maximum leakage current and voltage waveforms of the DC+_Porcelain insulator

It is observed in Figure 5-67 that the leakage current of the DC+_Porcelain insulator had an approximate linear increase of up to 110 mA, followed by an approximate linear decrease to 90 mA and then it became non-linear with very steep increases. It is also observed that the steep increases were followed by approximately linear decreases. The approximate linear increase in the beginning of the graph was caused by the establishment of a leakage current paths and an increase of the surface conductivity which could be caused by continuous wetting of the insulator surface by condensation, deliquescence process, rain drizzle and/or fog. When the leakage current reached a value of approximately 110 mA, the electrolytic conductive layer on the insulator surface vaporizes at the areas with the highest leakage current density which decreases the flow of the leakage current and eventually forms dry bands. It is assumed that there exist multiple leakage current paths on the insulator surface, at an instance. Thus, if a dry band forms on one leakage current path, the leakage current flowing on the insulator surface does not necessarily reduce to 0 A, but decreases linearly as the conductive layer vaporise. The high voltage differences over the dry bands polarize the air and electrical discharge activities occur which are presented as steep increases in the leakage current plot in Figure 5-67. The small steep increases represent weak electrical discharge activities (small, faint discharges) and the large steep increases represent prominent electrical discharge activities (visible discharges).

In the middle of the graph, the maximum peak leakage current saturated at 718 mA and then reduced instantaneously to 0 mA. This happened because the Mace fuse exploded and opened the circuit. The transient response of the smoothing capacitor and the capacitors in

parallel with the voltage divider resistors of the AC-to-DC converters reduced the system voltage to -3 kV at the moment at which the fuse exploded, as seen in Figure 5-67. The voltage recovers then immediately to the value it had before the fuse exploded.

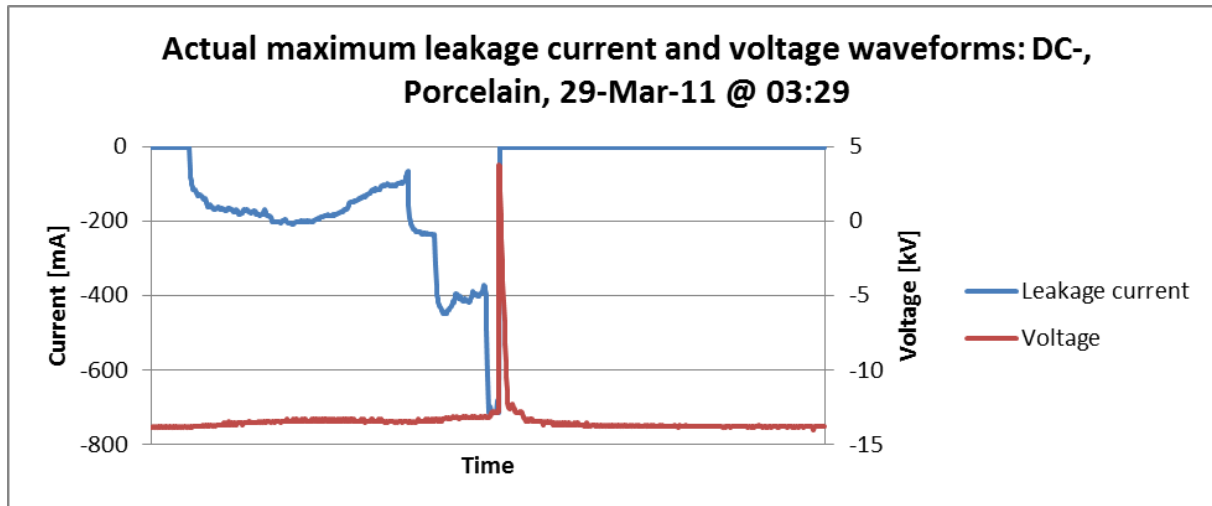
Figure 5-68: Actual maximum leakage current and voltage waveforms of DC- Porcelain insulator

It is observed in Figure 5-68 that the leakage current of the DC- Porcelain insulator starts with a very steep decrease to -100 mA and then decreases approximate linearly to -200 mA and then it increases approximate linearly to -100 mA. The approximate linear decrease in the middle section of the graph represents the forming of leakage current paths and an increase of the surface conductivity which could be caused by continuous wetting of the insulator surface by condensation, deliquescence process, rain drizzle and/or fog. When the leakage current reached a value of approximately -200 mA, the electrolytic conductive layer on the insulator surface vaporizes at the areas with the highest leakage current density which decreases the flow of the leakage current and eventually forms dry bands. It is assumed that there exist multiple leakage current paths on the insulator surface, at an instance. Thus, if a dry band forms on one leakage current path, the leakage current flowing on the insulator surface does not necessarily increase to 0 A, but increases linearly as the conductive layer vaporises to a value of -40 mA. The high voltage differences over the dry bands polarize the air and electrical discharge activities occur which are presented as steep decreases in the leakage current plot in Figure 5-68. The small steep decreases represent weak electrical discharge activities (small, faint discharges) and the large steep decreases represent prominent electrical discharge activities (visible discharges).

In the middle of the graph the maximum peak leakage current saturated at -716 mA and then increased instantaneously to 0 mA. This happened because the Mace fuse exploded and opened the circuit. The transient response of the smoothing capacitor and the capacitors in parallel with the voltage divider resistors of the AC-to-DC converters increased the system voltage to 3 kV at the exact moment at which the fuse exploded, as seen in Figure 5-68. The voltage recovers then immediately to the value it had before the fuse exploded.

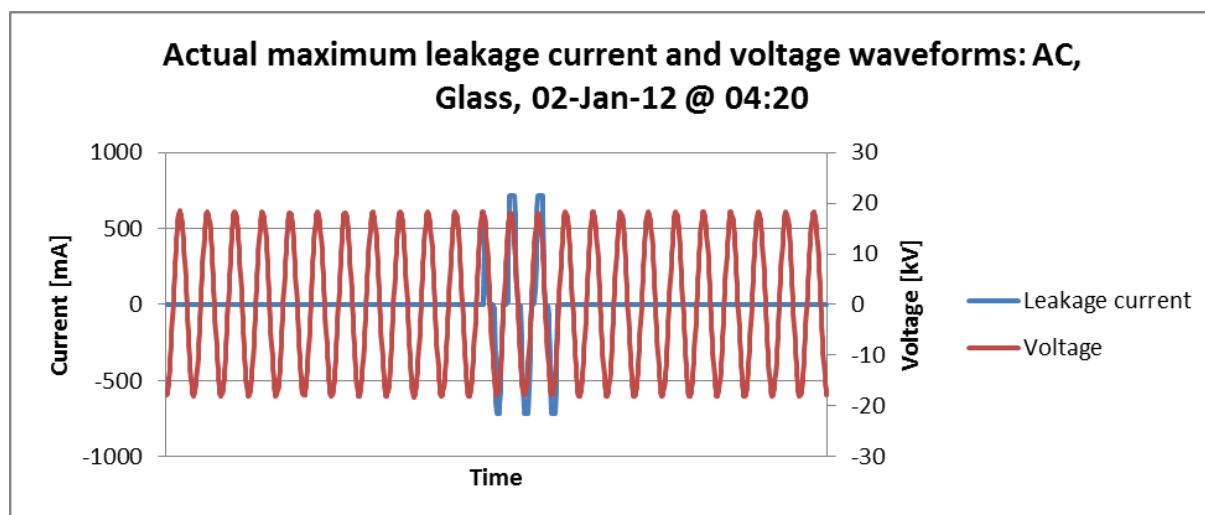
Figure 5-69: Actual maximum leakage current and voltage waveforms of the AC_Glass insulator

It is observed in Figure 5-69 that the AC leakage current has a non-sinusoidal waveform, which implies that the AC leakage current consists of higher harmonic content as well. It is further observed that the maximum peak leakage current saturated at a value of 716 mA.

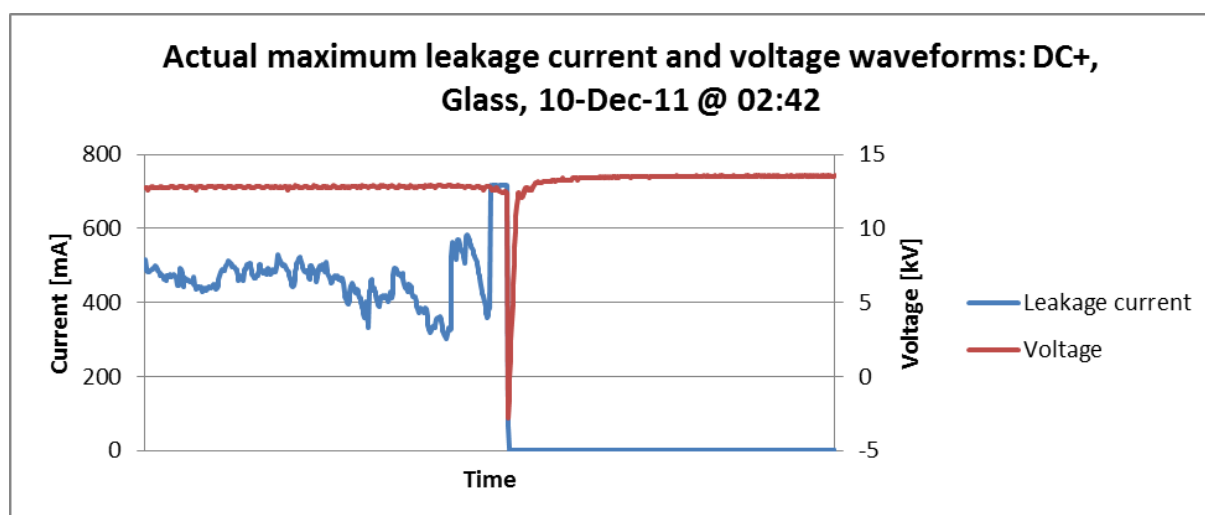
Figure 5-70: Actual maximum leakage current and voltage waveforms of the DC+_Glass insulator

It is observed in Figure 5-70 that the leakage current of the DC+_Glass insulator had a non-linear waveform with an approximate value of 500 mA at the beginning of the graph. It fluctuated around that value with small steep increases and decreases. The steep increases

became larger nearby the instance when the fuse exploded. The steep increases in the leakage current were caused by electrical discharge activity where the small steep increases represents weak electrical discharge activity (small, faint discharges) and the large steep increases represent prominent electrical discharge activities (visible discharges).

In the middle of the graph, the maximum peak leakage current saturated at 717.8 mA and then reduced instantaneously to 0 mA. This happened because the Mace fuse exploded and opened the circuit. The transient response of the smoothing capacitor and the capacitors in parallel with the voltage divider resistors of the AC-to-DC converters reduced the system voltage to -3 kV at the moment the fuse exploded as seen in Figure 5-70. The voltage then recovers immediately to the value it had before the fuse exploded.

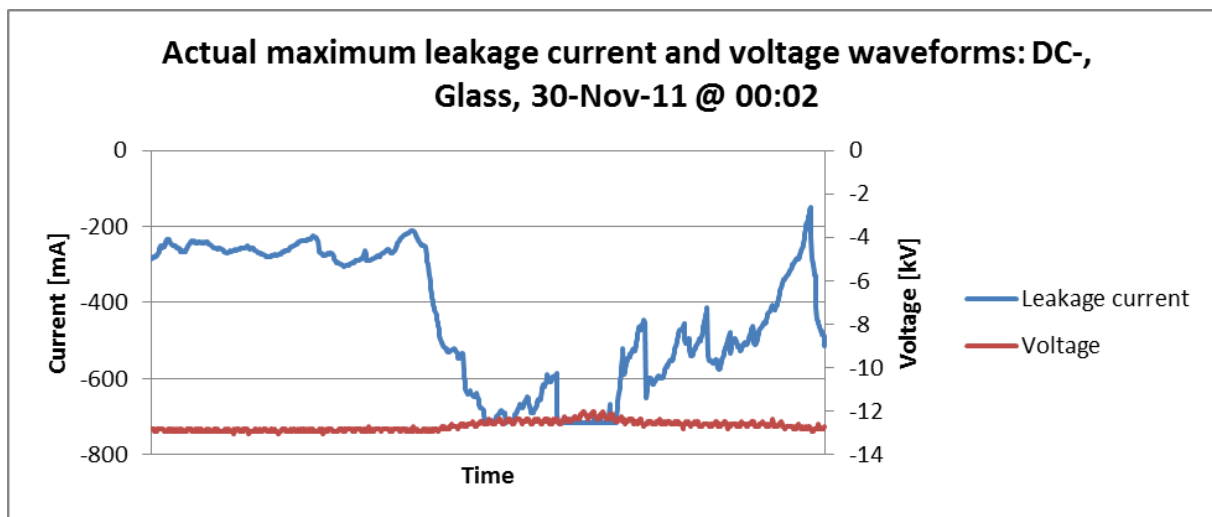
Figure 5-71: Actual maximum leakage current and voltage waveforms of the DC-_Glass insulator

It is observed in Figure 5-71 that the leakage current of the DC-_Glass insulator had a non-linear waveform with an approximate value of -250 mA at the beginning of the graph. It fluctuated around that value with small steep increases and decreases. The steep decreases became large nearby the maximum negative peak leakage current. The steep decreases in the leakage current were caused by electrical discharge activity. The small steep decreases represent weak electrical discharge activity (small, faint discharges) and the large steep decreases represent prominent electrical discharge activities (visible discharges). The steep increases in the graph represent the extinguished electrical discharge activities and the approximate linear increases near the end of the graph represent the evaporation process of the solution layer responsible for the leakage current paths. In the middle of the graph the

maximum peak leakage current saturated at -717 mA and it should be noted that no fuse explosion activity occurred in this graph.
